Bowdun Offshore Wind Farm, Onshore EIA Report

Volume 2, Appendix 11.2: Schedule of
Watercourse Crossings

TWP-BOW-JCB-ONE-RPT-00020 | November 2025

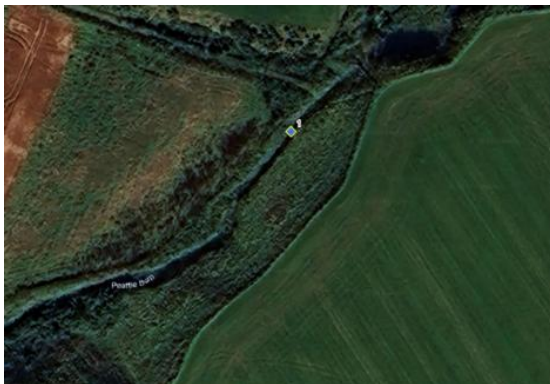
WX1: Peattie Burn (Tributary of the Bervie Water)	
Watercourse Description	
<ul style="list-style-type: none"> • Channel Type: Meandering • Gradient: Gentle • Valley Form: No obvious valley sides • Bank Condition: N/A • Bed Material: N/A • Riparian Corridor: Agricultural • Flow Condition: N/A 	<ul style="list-style-type: none"> • Water Width (m): ~1.10 • Water Depth (m): N/A • Bankfull Width (m): ~2.5 • Bankfull Height (m): N/A • Flooded Bankfull Width (m): ~4.00 • Flood Bankfull Height (m): N/A <p>Notes: Approx. location: 380883 772549. Location not accessible due to landowner access. Assessment carried out through desk study. Shown on 1:50,000 scale OS map.</p> <p>Proposed Crossing Type: HDD</p> <p>EASR Authorisation Type: GBR</p>
Overview

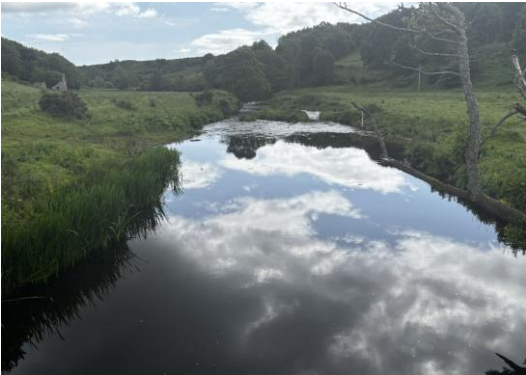
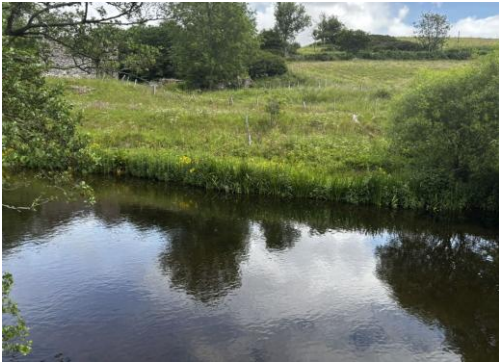
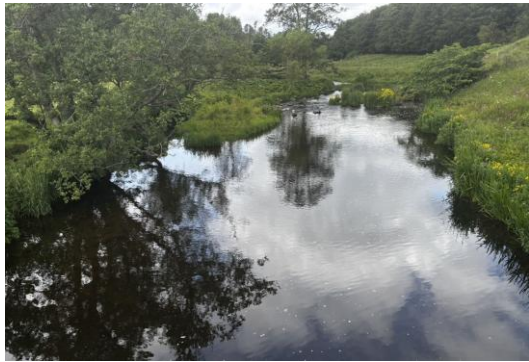
WX2: Bervie Water		
Watercourse Description		
<ul style="list-style-type: none"> • Channel Type: Wide, meandering • Gradient: Moderate • Valley Form: U shaped valley • Bank Condition: Stable, well-vegetated, some evidence of erosion • Bed Material: Cobbles, gravels, sands and some boulders • Riparian Corridor: Grassland and pasture • Flow Condition: Slow to Moderate 	<ul style="list-style-type: none"> • Water Width (m): ~10 • Water Depth (m): 1.10 – 1.50 • Bankfull Width (m): 10.70 • Bankfull Height (m): 2.00 • Flooded Bankfull Width (m): ~19.20 • Flood Bankfull Height (m): ~2.70 <p>Notes: Approximate location 380586 774332. Shown on 1:50,000 scale OS map.</p> <p>Proposed Crossing Type: HDD EASR Authorisation Type: GBR</p>	
Watercourse Photographs		
Upstream	Across	Downstream

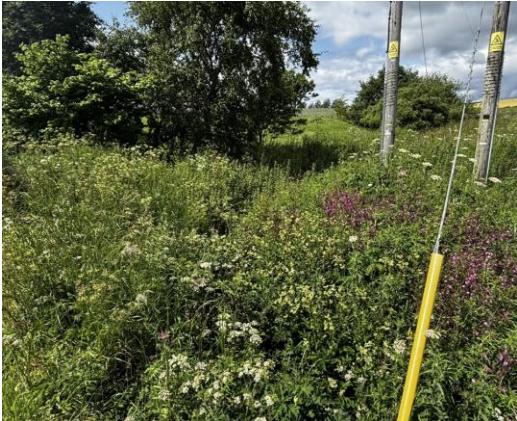
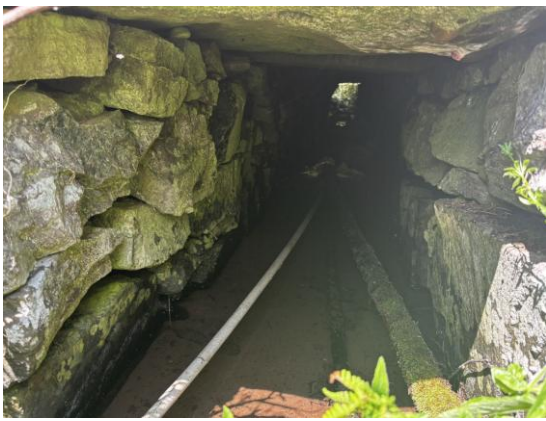
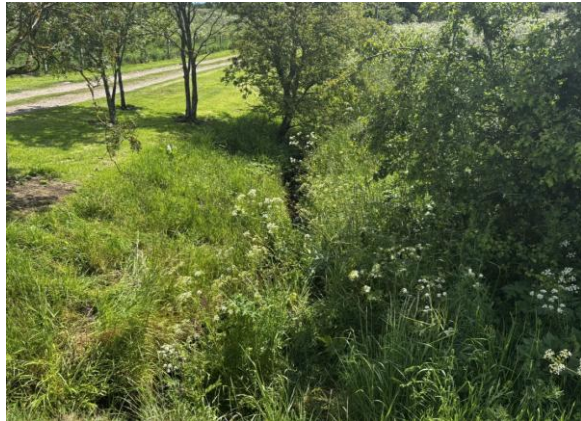
WX3: Unnamed Tributary of the Bervie Water		
Watercourse Description		
<ul style="list-style-type: none"> • Channel Type: Artificially modified burn • Gradient: Gentle • Valley Form: No obvious valley sides • Bank Condition: Stable • Bed Material: Gravel and sand • Riparian Corridor: Grassland and pasture • Flow Condition: Slow 	<ul style="list-style-type: none"> • Water Width (m): 0.55 • Water Depth (m): 0.03 • Bankfull Width (m): 0.80 • Bankfull Height (m): 0.60 • Flooded Bankfull Width (m): 2.90 • Flood Bankfull Height (m): 2.00 <p>Notes: Approximate location 380711 774888. Shown on 1:50,000 scale OS map. Proposed Crossing Type: Open Cut Trenching EASR Authorisation Type: Registration</p>	
Watercourse Photographs		
Upstream	Across	Downstream

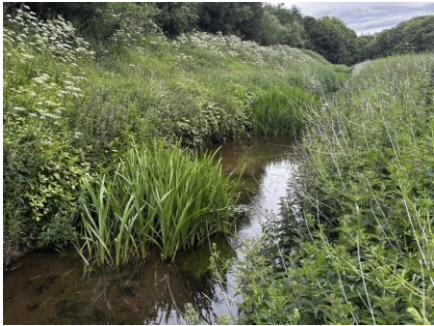
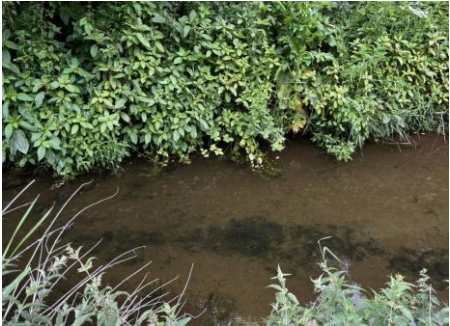
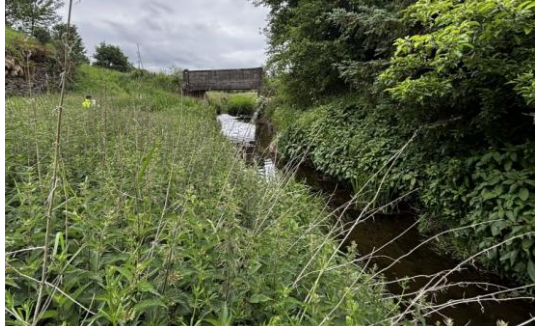
WX4: Forthie Water		
Watercourse Description		
<ul style="list-style-type: none"> • Channel Type: Gentle meandering • Gradient: Gentle • Valley Form: No obvious valley sides. • Bank Condition: Stable, Well-vegetated • Bed Material: Gravel and sand • Riparian Corridor: Grassland/pasture • Flow Condition: Slow 	<ul style="list-style-type: none"> • Water Width (m): ~3.50 • Water Depth (m): 0.52 • Bankfull Width (m): 4.50 • Bankfull Height (m): 1.55 • Flooded Bankfull Width (m): N/A* • Flood Bankfull Height (m): 1.85 <p>Notes: Approximate location 379027 779460. Shown on a 1:50,000 scale OS map. *Floodplain over left bank largely open and flat. Proposed Crossing Type: HDD EASR Authorisation Type: GBR</p>	
Watercourse Photographs		
Upstream	Across	Downstream

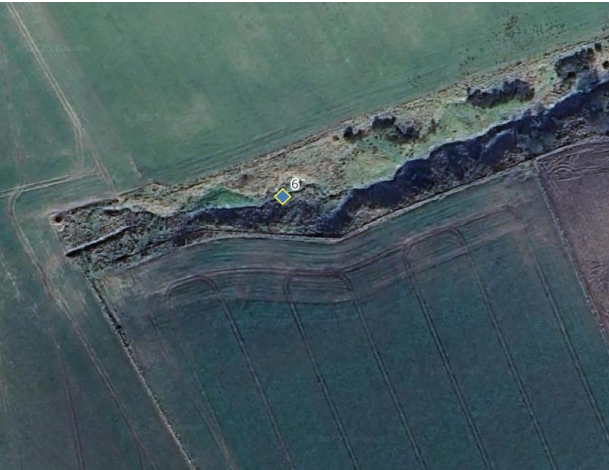
WX6: Unnamed Tributary of Drumlithie Burn	
Watercourse Description	
<ul style="list-style-type: none"> • Channel Type: Meandering burn • Gradient: N/A • Valley Form: Shallow V-shaped valley • Bank Condition: N/A • Bed Material: N/A • Riparian Corridor: Agricultural • Flow Condition: N/A 	<ul style="list-style-type: none"> • Water Width (m): 1.10 • Water Depth (m): N/A • Bankfull Width (m): 2.1 • Bankfull Height (m): N/A • Flooded Bankfull Width (m): 4.1 • Flood Bankfull Height (m): N/A <p>Notes: Approximate location: 378310 782136. Location not accessible due to landowner access. Assessment carried out through desk study. Shown on 1:50,000 scale OS map.</p> <p>Proposed Crossing Type: Open Cut Trenching</p> <p>EASR Authorisation Type: Registration</p>
Overview

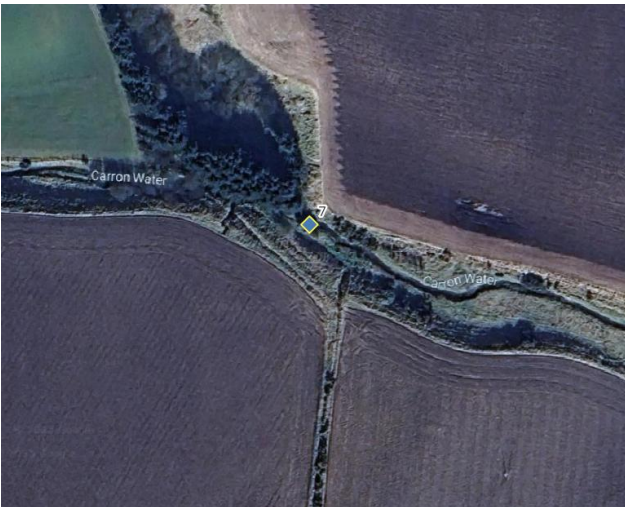
WX7: Carron Water	
Watercourse Description	
<ul style="list-style-type: none"> • Channel Type: Meandering • Gradient: N/A • Valley Form: No obvious valley sides • Bank Condition: N/A • Bed Material: N/A • Riparian Corridor: Agricultural • Flow Condition: N/A 	<ul style="list-style-type: none"> • Water Width (m): 2.70 • Water Depth (m): N/A • Bankfull Width (m): 3.0 • Bankfull Height (m): N/A • Flooded Bankfull Width (m): 5.35 • Flood Bankfull Height (m): N/A <p>Notes: Approximate location 378074 783584. Location not accessible due to landowner access. Assessment carried out through desk study. Shown on a 1:50,000 scale OS map.</p> <p>Proposed Crossing Type: HDD EASR Authorisation Type: GBR</p>
Overview

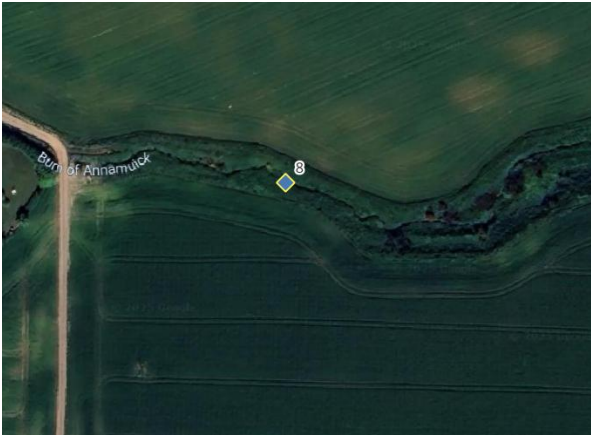
WX8: Burn of Annamuick	
Watercourse Description	
<ul style="list-style-type: none"> • Channel Type: Meandering • Gradient: N/A • Valley Form: No obvious valley sides • Bank Condition: N/A • Bed Material: N/A • Riparian Corridor: Agricultural • Flow Condition: N/A 	<ul style="list-style-type: none"> • Water Width (m): 0.90 • Water Depth (m): N/A • Bankfull Width (m): 1.40 • Bankfull Height (m): N/A • Flooded Bankfull Width (m): 1.90 • Flood Bankfull Height (m): N/A <p>Notes: Approximate location 379682 784624. Location not accessible due to landowner access. Assessment carried out through desk study. Shown on 1:50,000 scale OS map.</p> <p>Proposed Crossing Type: Open Cut Trenching</p> <p>EASR Authorisation Type: Registration</p>
Overview

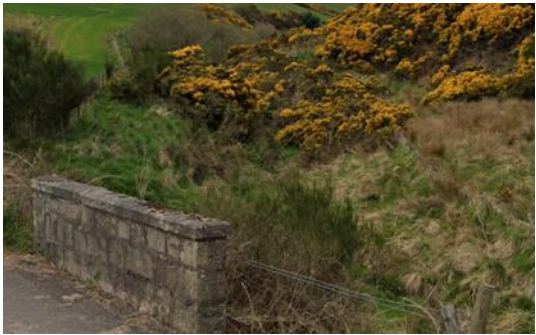
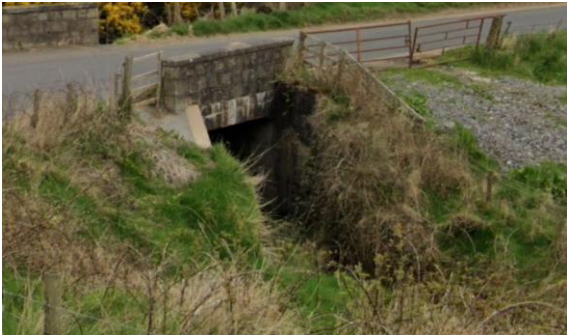
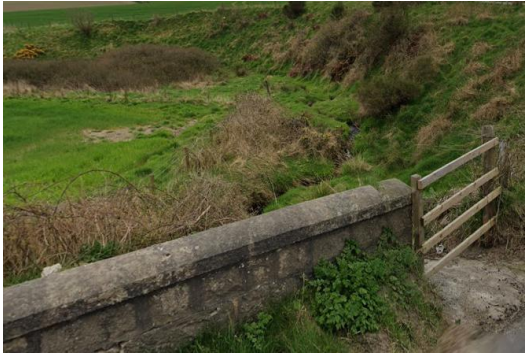
WX9: Burn of Elhill		
Watercourse Description		
<ul style="list-style-type: none"> • Channel Type: Meandering • Gradient: Moderate • Valley Form: Asymmetrical valley • Bank Condition: N/A • Bed Material: N/A • Riparian Corridor: Agricultural • Flow Condition: N/A 	<ul style="list-style-type: none"> • Water Width (m): 1.3 • Water Depth (m): N/A • Bankfull Width (m): 1.5 • Bankfull Height (m): N/A • Flooded Bankfull Width (m): N/A • Flood Bankfull Height (m): N/A <p>Notes: Approximate location 379747 784902, visual observations from roadside only. Location not accessible due to landowner access. Assessment carried out through desk study. Shown on 1:50,000 scale OS map.</p> <p>Proposed Crossing Type: Existing Crossing EASR Authorisation Type: N/A</p>	
Watercourse Photographs		
Upstream	Across	Downstream

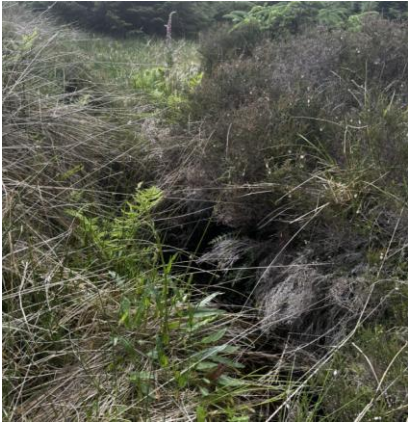
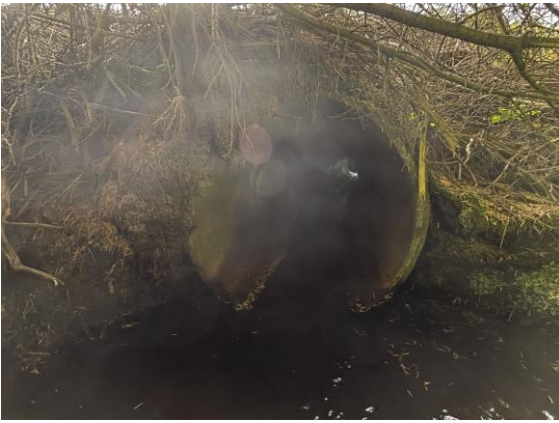
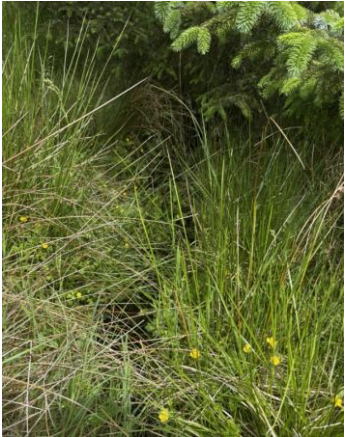
WX10: Burn of Day		
Watercourse Description		
<ul style="list-style-type: none"> • Channel Type: Artificially modified burn • Gradient: Gentle to Moderate • Valley Form: No obvious valley sides • Bank Condition: Stable with undercutting of banks present • Bed Material: Silt and sands • Riparian Corridor: Mixed woodland • Flow Condition: Stagnant/slow 	<ul style="list-style-type: none"> • Water Width (m): 1.95 • Water Depth (m): 0.38 • Bankfull Width (m): 3.4 • Bankfull Height (m): 0.65 • Flooded Bankfull Width (m): N/A • Flood Bankfull Height (m): N/A <p>Notes: Approximate location 380209 786744. Shown on 1:50,000 scale OS map. *No defined flooded bankfull profile.</p> <p>Proposed Crossing Type: Open Cut Trenching</p> <p>EASR Authorisation Type: Registration</p>	
Watercourse Photographs		
Upstream	Across	Downstream

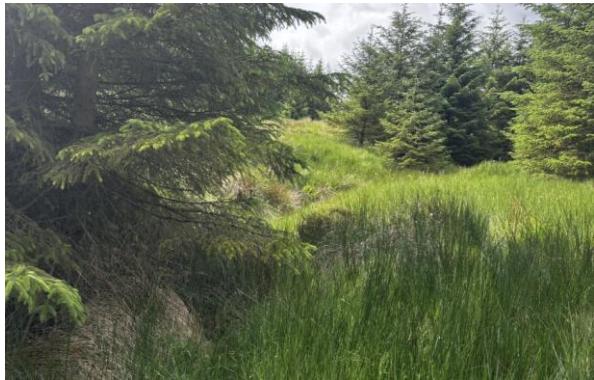
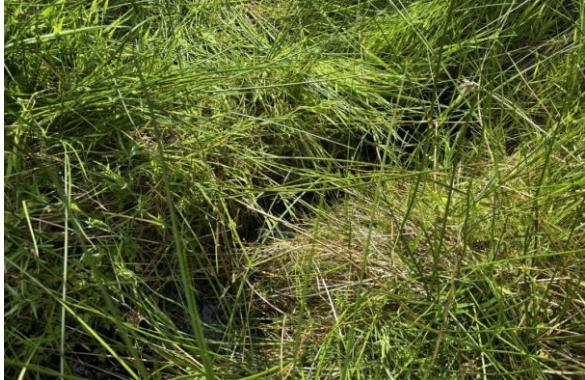
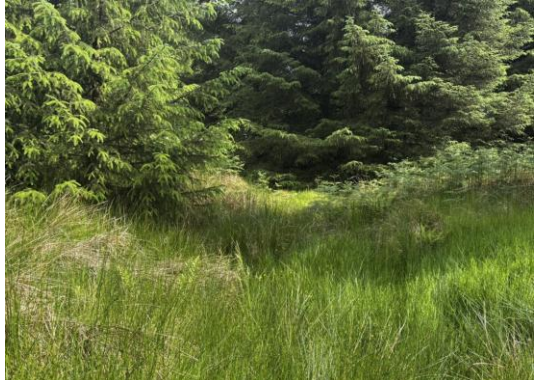
WX11: Whiting Burn		
Watercourse Description		
<ul style="list-style-type: none"> • Channel Type: Artificially modified burn • Gradient: Moderate/steep • Valley Form: Shallow V-shaped valley • Bank Condition: Stable • Bed Material: Gravel/sand • Riparian Corridor: Mixed woodland • Flow Condition: Moderate 	<ul style="list-style-type: none"> • Water Width (m): 0.35 • Water Depth (m): 0.15 • Bankfull Width (m): 0.60 • Bankfull Height (m): 0.50 • Flooded Bankfull Width (m): ~4.30 • Flood Bankfull Height (m): ~2.10 <p>Notes: Approximate location 378513 786142. Shown on 1:50,000 scale OS map.</p> <p>Proposed Crossing Type: Open Cut Trenching</p> <p>EASR Authorisation Type: Registration</p>	
Watercourse Photographs		
Upstream	Across	Downstream

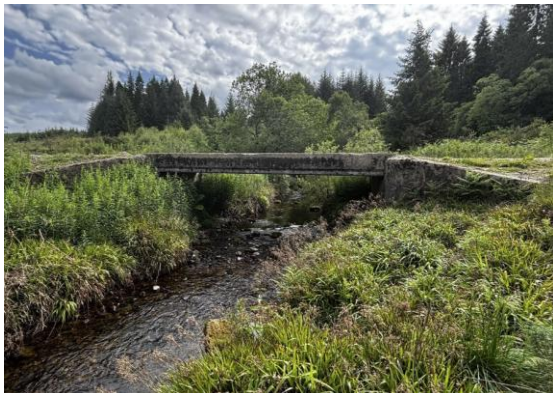
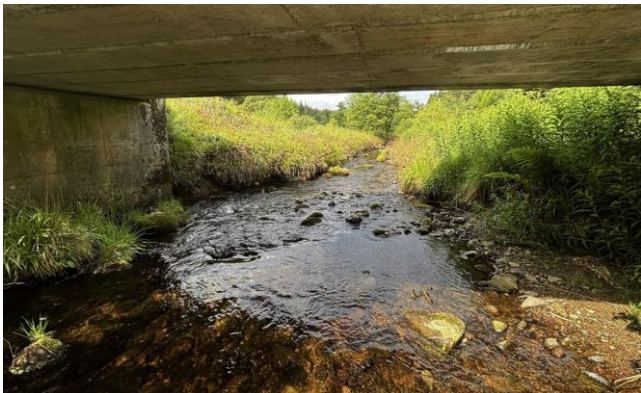
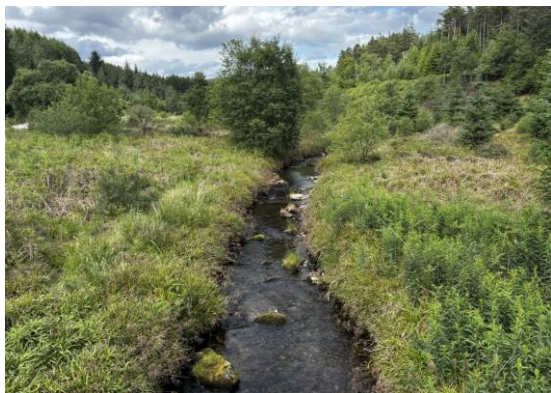
WX12: Cowie Water		
Watercourse Description		
<ul style="list-style-type: none"> • Channel Type: Meandering • Gradient: Moderate • Valley Form: No obvious valley sides • Bank Condition: Undercutting present • Bed Material: Boulders, cobbles, gravels and sands • Riparian Corridor: Mixed woodland • Flow Condition: Moderate 	<ul style="list-style-type: none"> • Water Width (m): 3.50 • Water Depth (m): 0.17 • Bankfull Width (m): 4.00 • Bankfull Height (m): 1.40 to 1.65 (angled) • Flooded Bankfull Width (m): 6.80 • Flood Bankfull Height (m): 2.20 <p>Notes: Approximate location 376463 787378. Shown on 1:50,000 scale OS map. Proposed Crossing Type: Existing Crossing EASR Authorisation Type: N/A</p>	
Watercourse Photographs		
Upstream	Across	Downstream

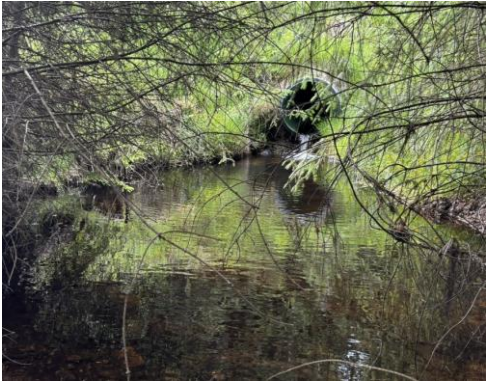
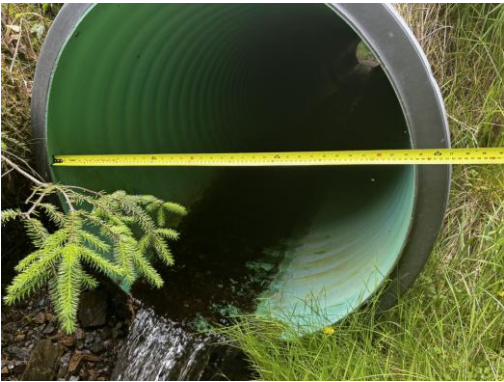
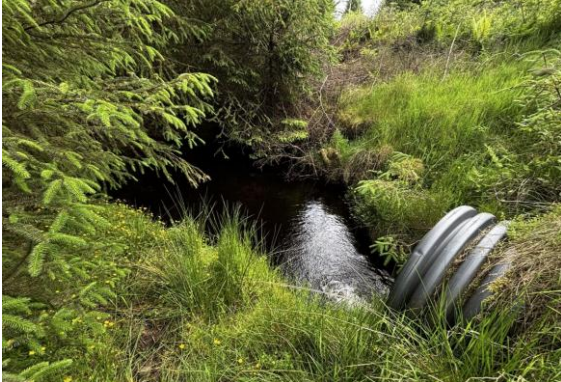
WX13: West Dumer Burn		
Watercourse Description		
<ul style="list-style-type: none"> • Channel Type: Meandering burn • Gradient: Gentle/moderate • Valley Form: V-shaped valley • Bank Condition: Undercutting present • Bed Material: Cobble, gravels and sand • Riparian Corridor: Mixed woodland • Flow Condition: Moderate/slow 	<ul style="list-style-type: none"> • Water Width (m): 0.80 • Water Depth (m): 0.03 – 0.15 • Bankfull Width (m): 1.72 • Bankfull Height (m): 0.67 • Flooded Bankfull Width (m): 6.10 • Flood Bankfull Height (m): 1.65 <p>Notes: Approximate location 376577 787822. Shown on 1:50,000 scale OS map.</p> <p>Proposed Crossing Type: Existing Crossing</p> <p>EASR Authorisation Type: N/A</p>	
Watercourse Photographs		
Upstream	Across	Downstream

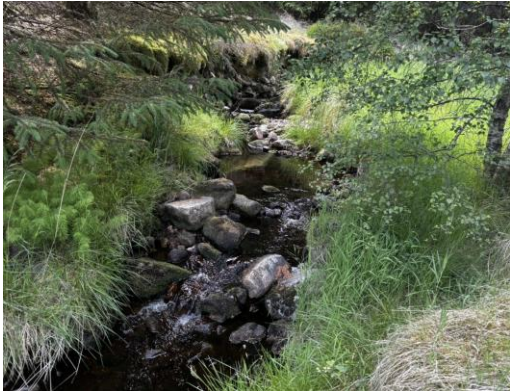
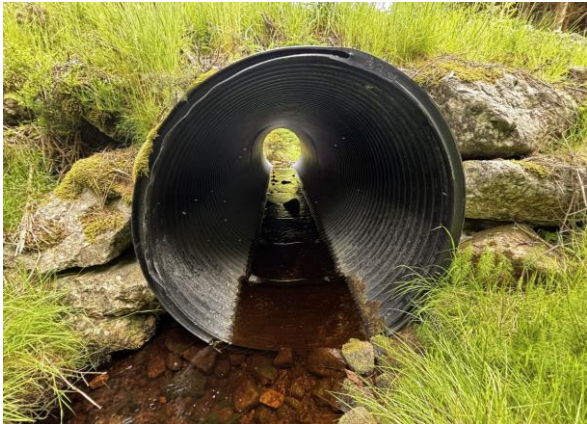
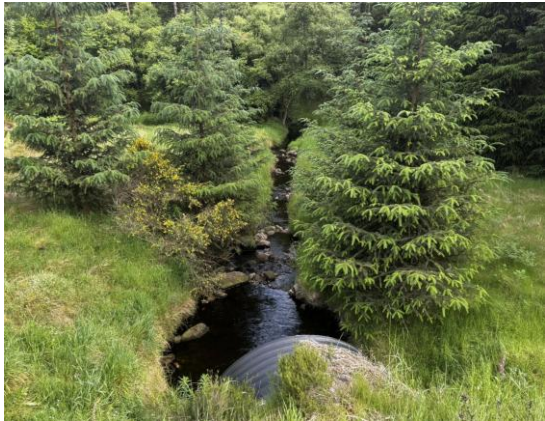
WX14: East Dumer Burn		
Watercourse Description		
<ul style="list-style-type: none"> • Channel Type: Meandering burn • Gradient: Moderate • Valley Form: Shallow V-shaped valley • Bank Condition: Actively eroding • Bed Material: Boulders, cobbles and gravels • Riparian Corridor: Mixed woodland • Flow Condition: Moderate 	<ul style="list-style-type: none"> • Water Width (m): 1.55 • Water Depth (m): 0.08 • Bankfull Width (m): 2.08 • Bankfull Height (m): 0.57 • Flooded Bankfull Width (m): 4.71 • Flood Bankfull Height (m): 1.60 <p>Notes: Approximate location 376577 787934. Shown on 1:50,000 scale OS map. Proposed Crossing Type: Existing Crossing EASR Authorisation Type: N/A</p>	
Watercourse Photographs		
Upstream	Across	Downstream

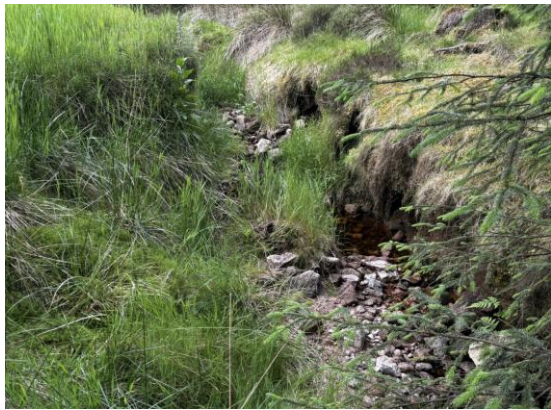
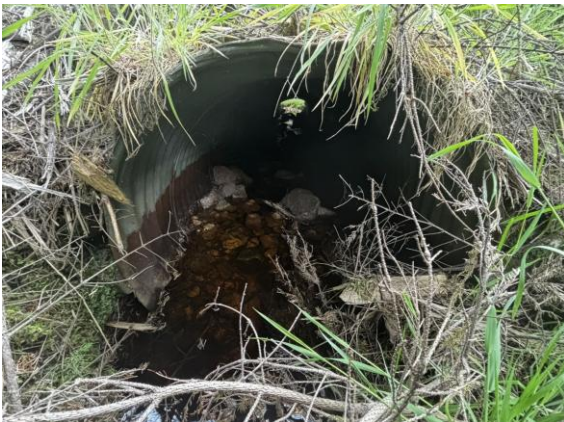
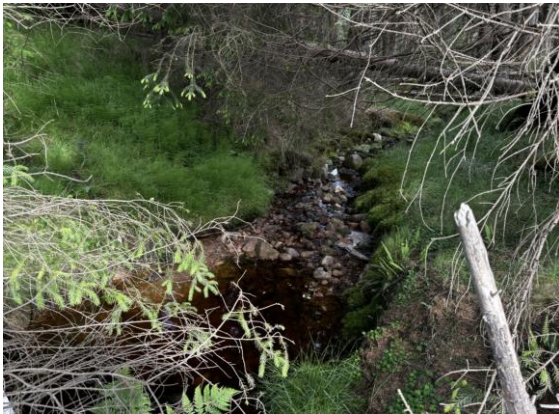
WX15: Irish Burn		
Watercourse Description		
<ul style="list-style-type: none"> • Channel Type: Meandering burn • Gradient: Moderate • Valley Form: V-shaped valley • Bank Condition: Actively eroding • Bed Material: Boulders, cobbles and gravels • Riparian Corridor: Mixed woodland • Flow Condition: Slow 	<ul style="list-style-type: none"> • Water Width (m): <0.05 • Water Depth (m): 0.05 • Bankfull Width (m): 3.05 • Bankfull Height (m): 1.68 • Flooded Bankfull Width (m): N/A • Flood Bankfull Height (m): N/A <p>Notes: Approximate location 377126 788265. Shown on 1:50,000 scale OS map.</p> <p>Proposed Crossing Type: Existing Crossing</p> <p>EASR Authorisation Type: N/A</p>	
Watercourse Photographs		
Upstream	Across	Downstream

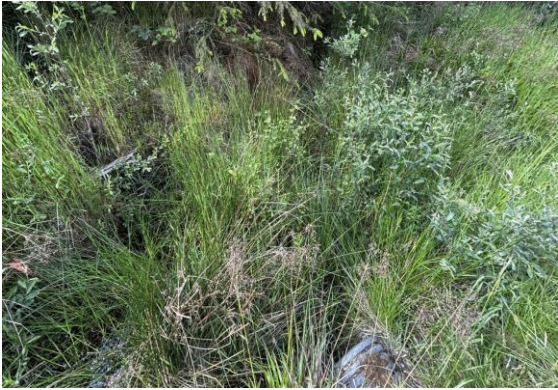
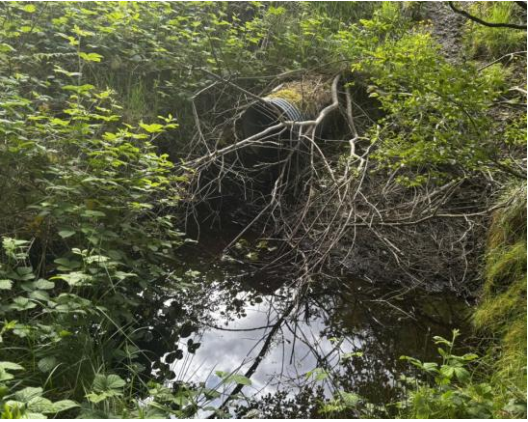
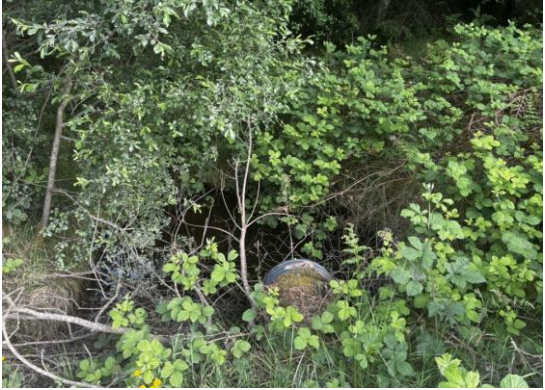
WX16: Unnamed Tributary to Cowie Water		
Watercourse Description		
<ul style="list-style-type: none"> • Channel Type: Artificially modified burn • Gradient: Moderate to Steep • Valley Form: Shallow V-shaped valley • Bank Condition: Stable • Bed Material: Silts and sands • Riparian Corridor: Mixed woodland • Flow Condition: Slow 	<ul style="list-style-type: none"> • Water Width (m): 0.17 • Water Depth (m): 0.14 • Bankfull Width (m): 0.75 • Bankfull Height (m): 0.70 • Flooded Bankfull Width (m): N/A • Flood Bankfull Height (m): N/A <p>Notes: Approximate location 378282 788370. Shown on 1:50,000 scale OS map. No defined flooded bankfull profile. Proposed Crossing Type: Existing Crossing EASR Authorisation Type: N/A</p>	
Watercourse Photographs		
Upstream	Across	Downstream

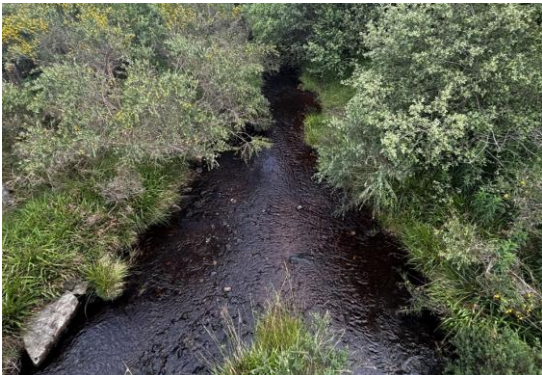
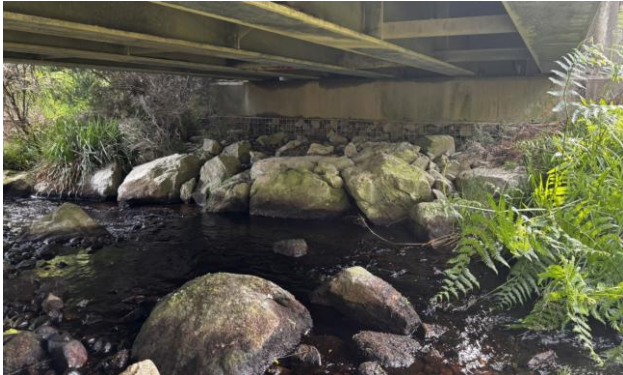
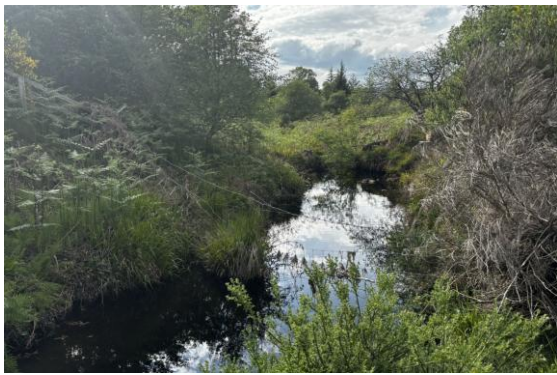
WX17: Black Burn		
Watercourse Description		
<ul style="list-style-type: none"> • Channel Type: Meandering • Gradient: Gentle • Valley Form: Shallow V-shaped valley • Bank Condition: Undercutting present • Bed Material: Cobbles, gravels and sands • Riparian Corridor: Mixed woodland • Flow Condition: Slow 	<ul style="list-style-type: none"> • Water Width (m): 4.10 • Water Depth (m): 0.29 • Bankfull Width (m): 5.53 • Bankfull Height (m): 0.65 • Flooded Bankfull Width (m): 12.95 • Flood Bankfull Height (m): 1.40 <p>Notes: Approximate location 378955 789368. Shown on 1:50,000 scale OS map. Scour protection present (gabion baskets and rock armour) in good condition.</p> <p>Proposed Crossing Type: Existing Crossing EASR Authorisation Type: N/A</p>	
Watercourse Photographs		
Upstream	Across	Downstream
